Navajo Abandoned Uranium Mine

Site Screen Report

Mine Name: Binalé 2
Mine ID: 222

Navajo AUM North Central Region

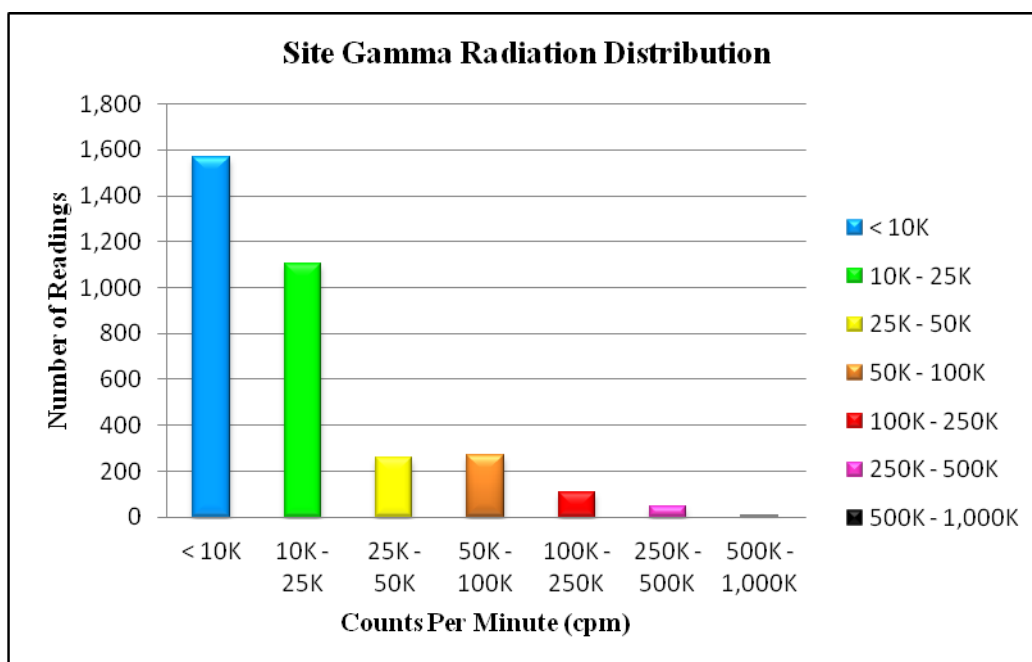
Distribution Chart and Statistics:

Site Gamma Radiation Statistics

Number of Readings	3,399
Minimum (cpm)	4,219
Maximum (cpm)	503,675
Mean (cpm)	26,216
Median (cpm)	10,798
Standard Deviation	51,106

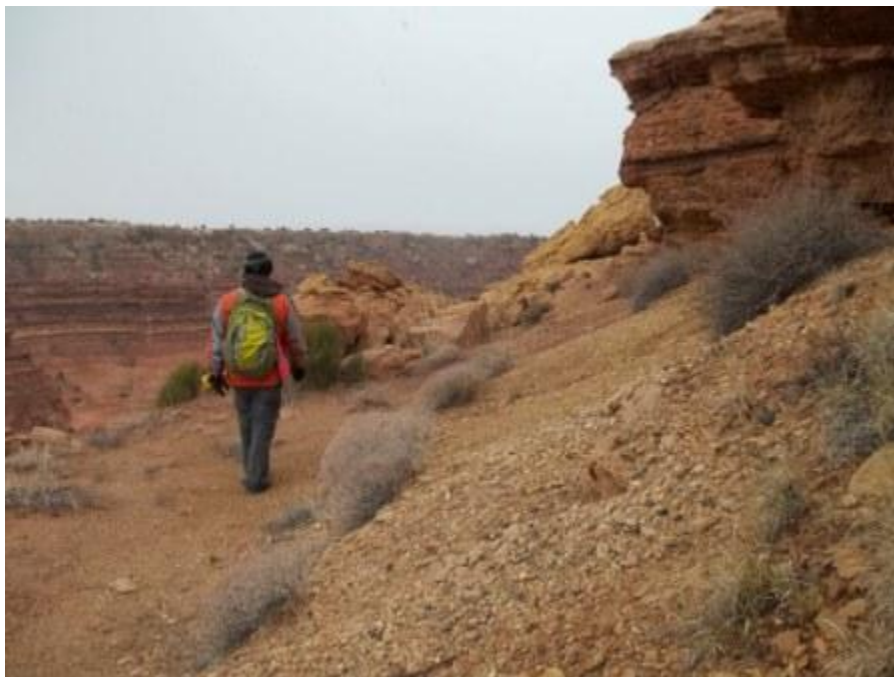
Photo 1

Waste rock along path leading into the site from the east, light grey, fine material

Mine Site #222 – Trail leading into the site

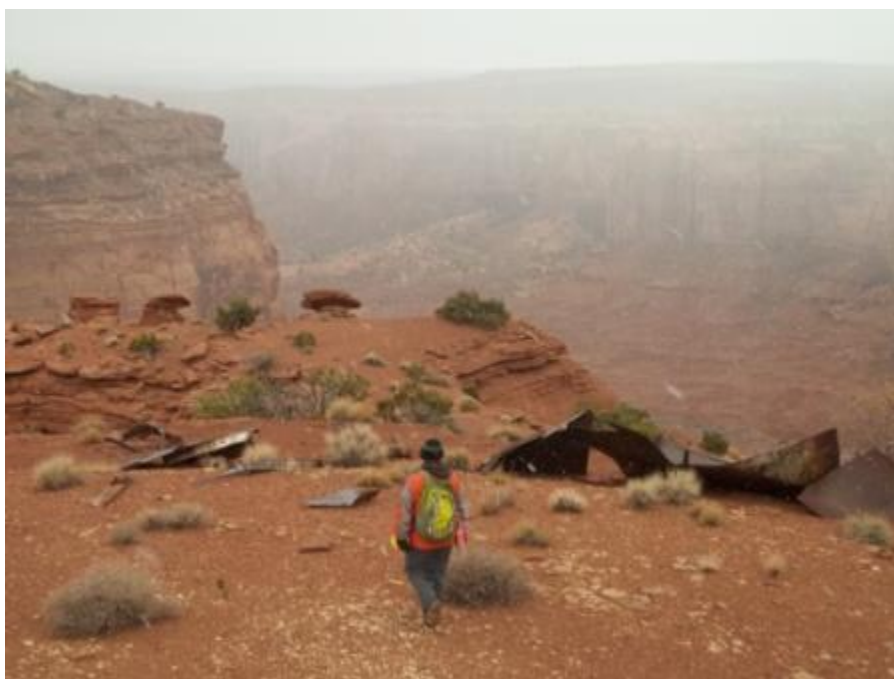
Photo 2

Test holes east of the site; metal debris southeast of the site

Mine Site #222 – Debris southeast of the site

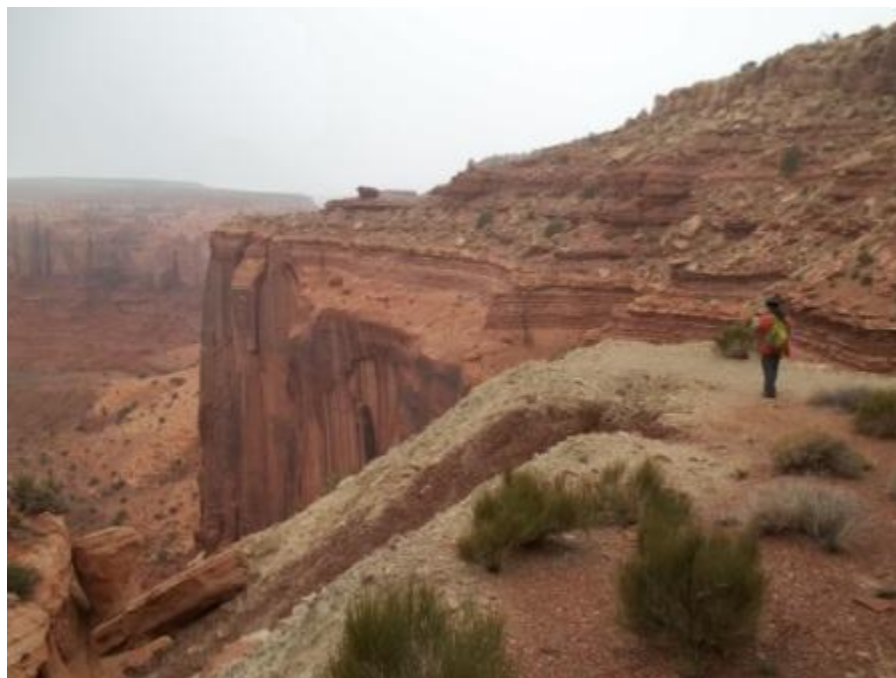
Photo 4

Mine Site #222 - Waste rock

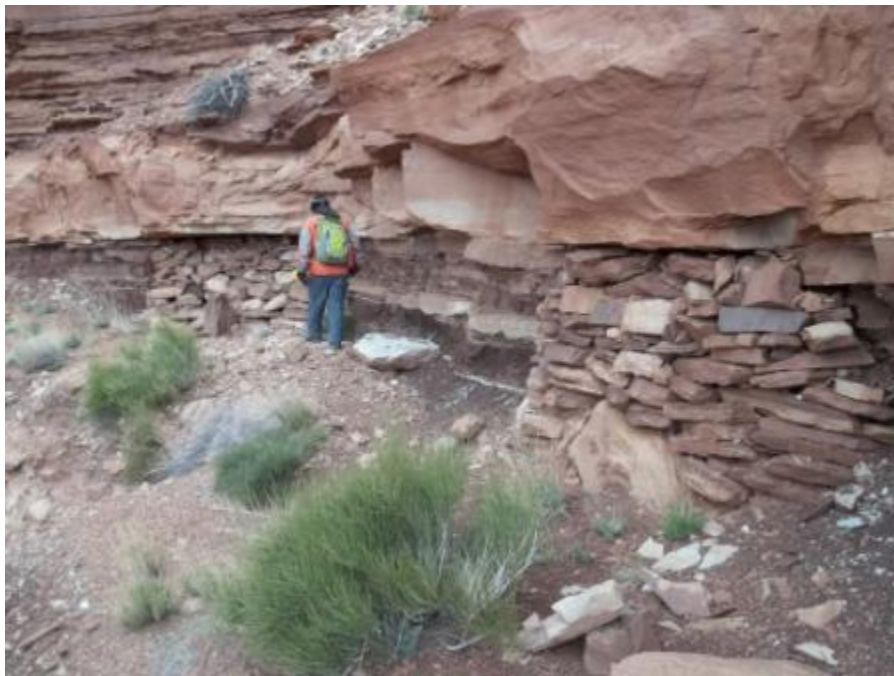
Photo 6

2 adits, both stone sealed, both approximately 5' x 10'

Mine Site #222 - Adits

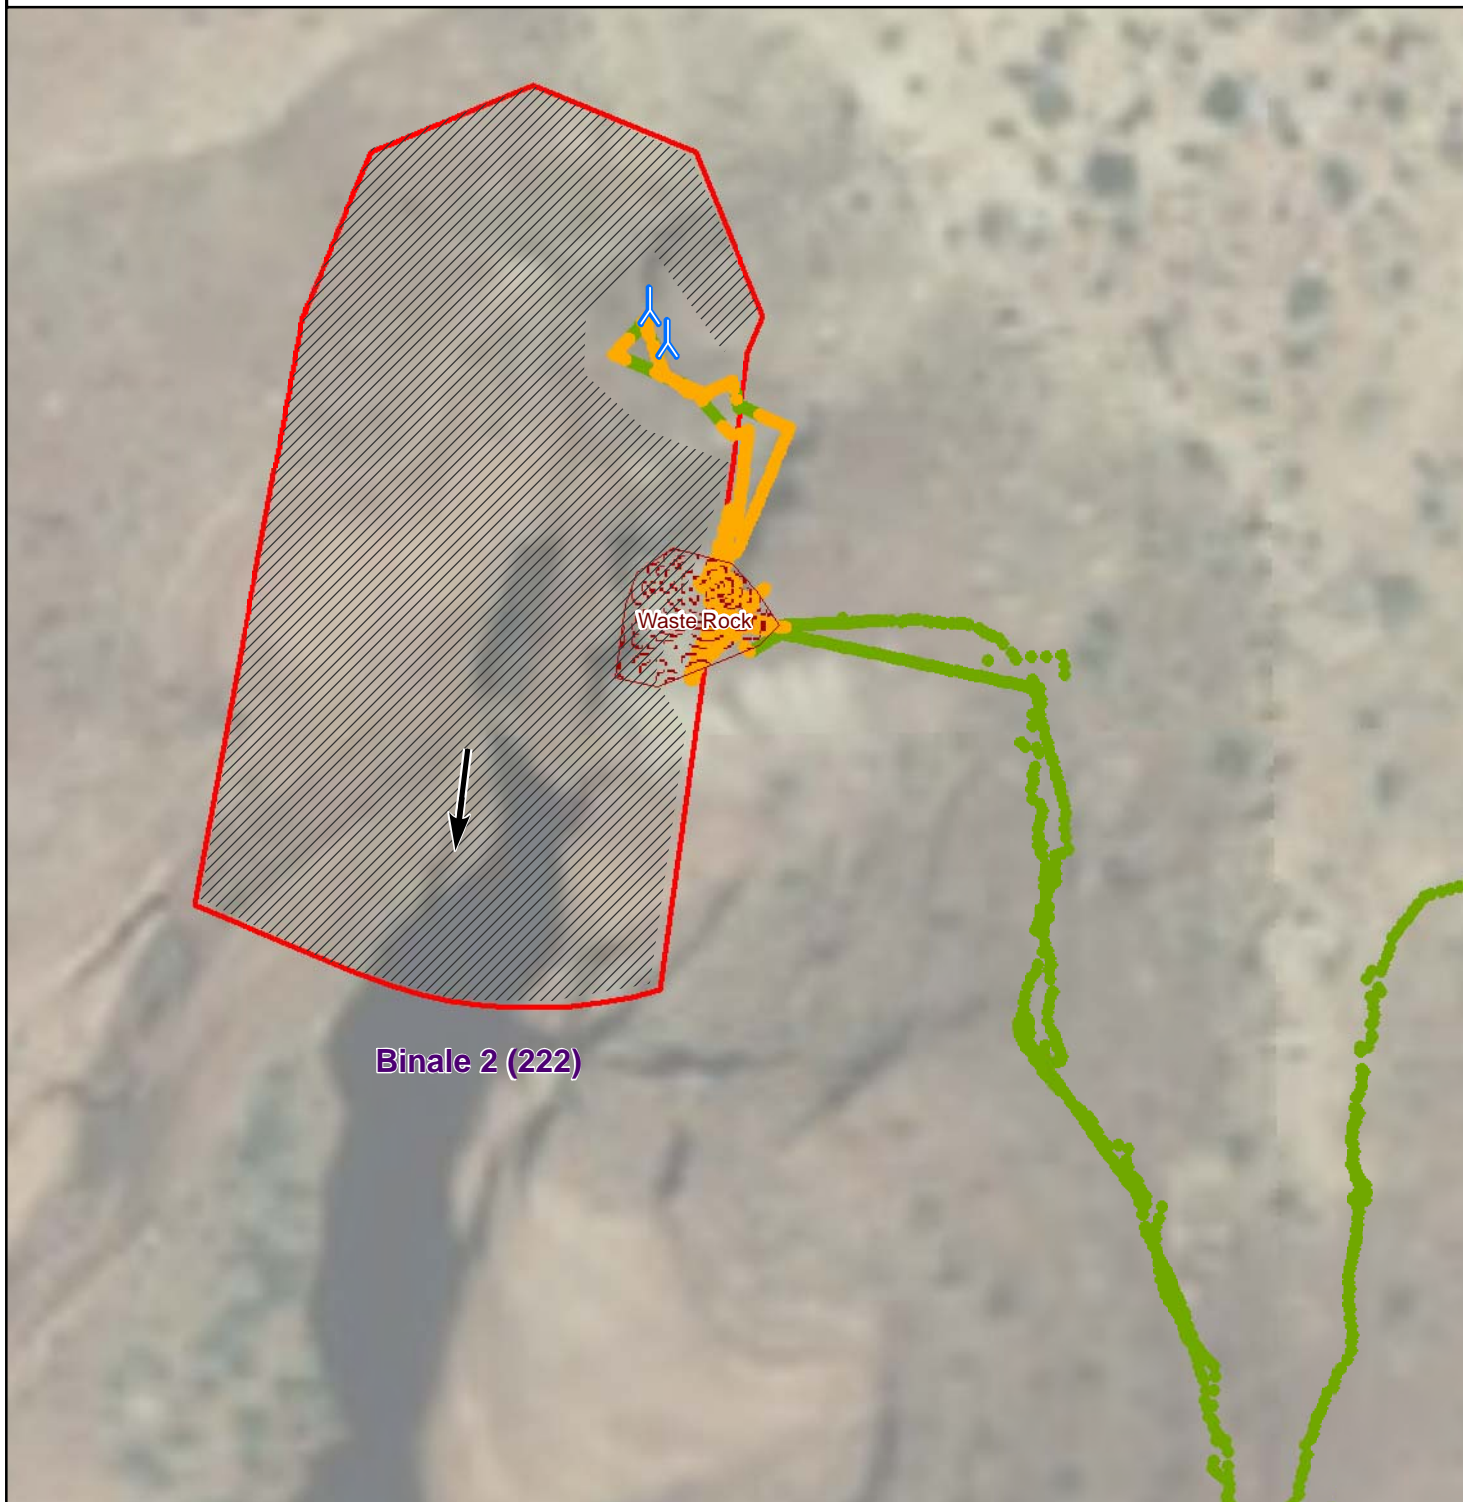
**Figure 1 - Gamma Radiation Measurements, Above Two Times Background
Binale 2 (222)
Oljato Chapter, Navajo Nation**

A total of 3,399 gamma radiation measurements were collected from the mine site, ranging from 4,219 cpm to 503,675 cpm. Maximum levels of approximately 500,000 cpm were found in the vicinity of the waste rock and 60,000 cpm were found at the entrance to the adits. The measurements are represented in Figures 1 and 2.

Gamma Radiation Measurements

Measured as counts per minute (cpm)

Average background 10,289 cpm

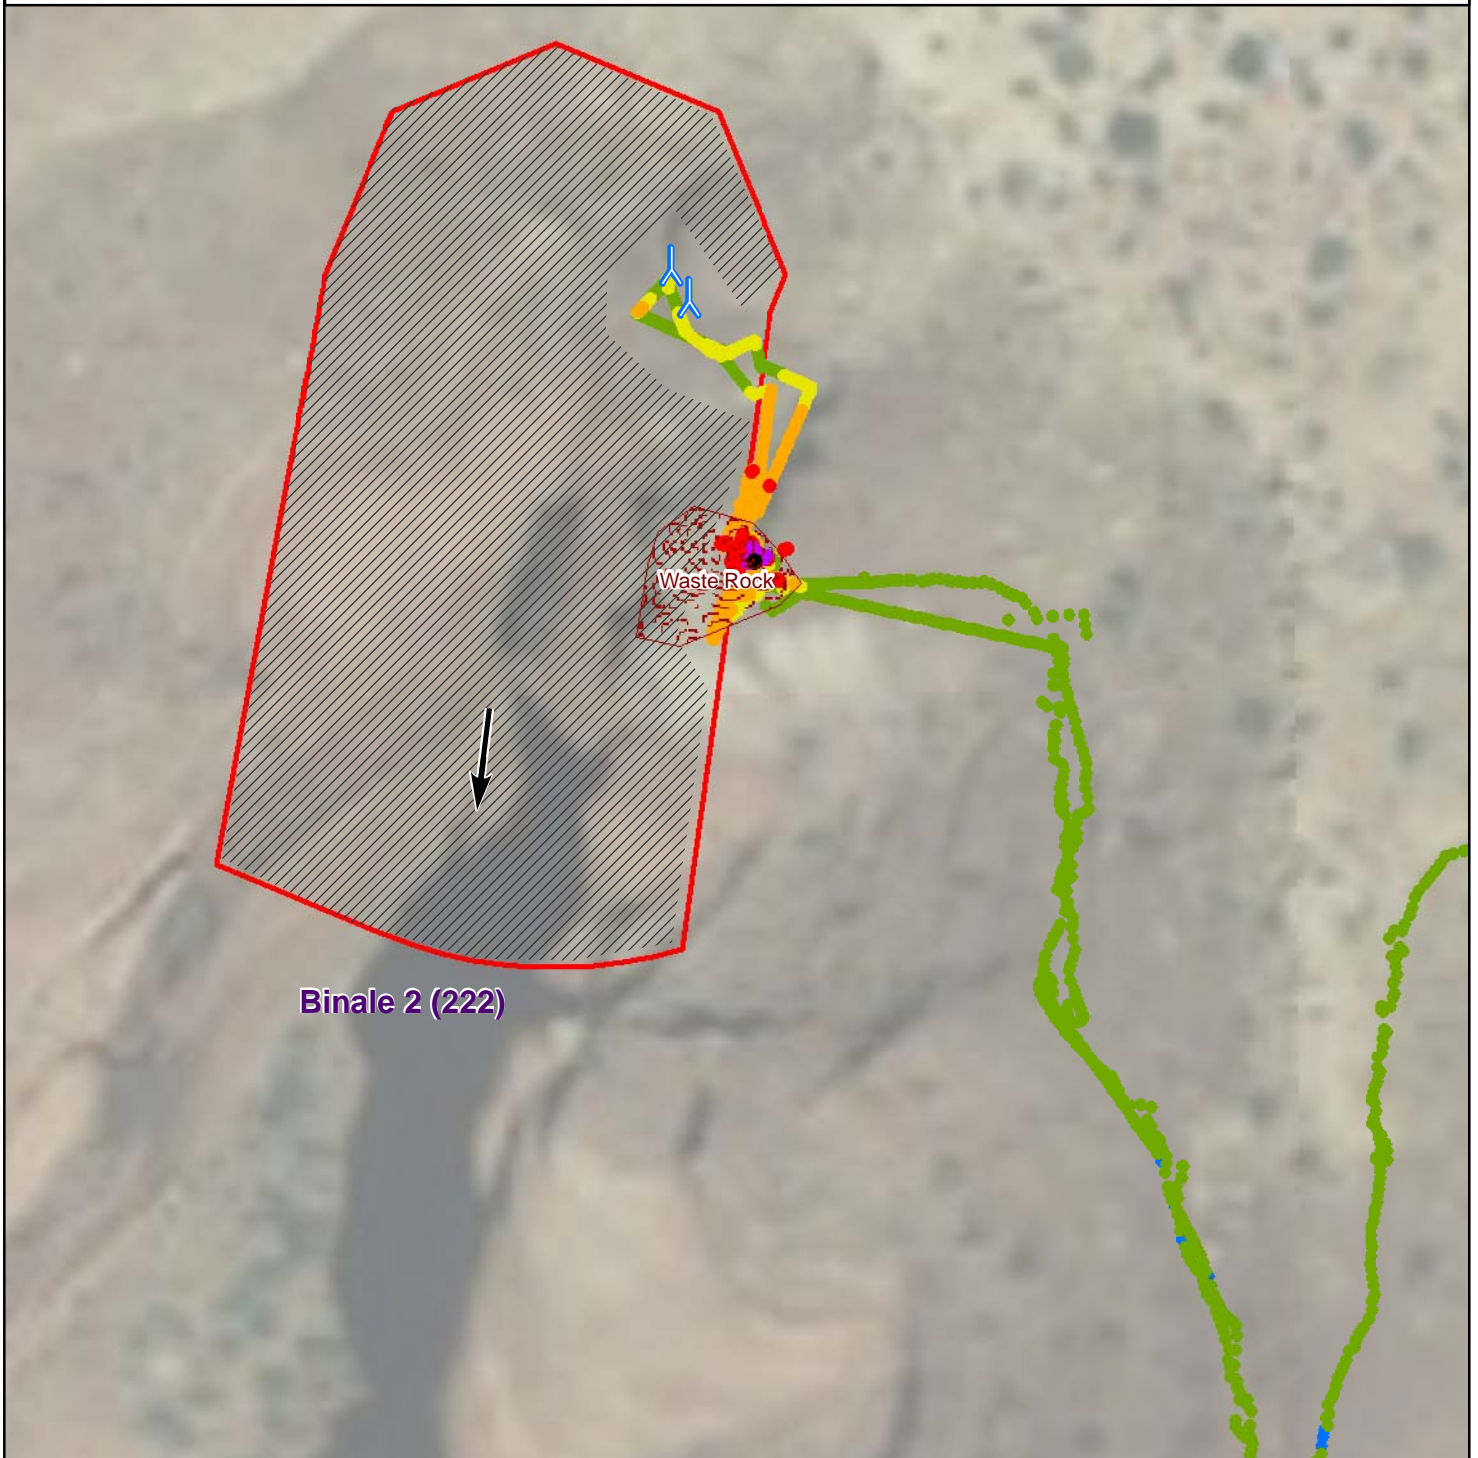
Figure 2 - Gamma Radiation Measurements
Binale 1 (222)
Oljato Chapter, Navajo Nation

Gamma Radiation Measurements

- 0 - 10,000 cpm
- 10,000 - 25,000 cpm
- 25,000 - 50,000 cpm
- 50,000 - 100,000 cpm
- 100,000 - 250,000 cpm
- 250,000 - 500,000 cpm
- 500,000 - 1,000,000 cpm

Average background 10,289 cpm
